DETECTION OF WATER LEAKS IN FOUM EL-GHERZA DAM (ALGERIA)

N. Hocini and A.S. Moulla

Applied Hydrology and Sedimentology Department Centre de Recherche Nucléaire
d'Alger (CRNA), P. O. Box 399, Alger-Gare,
16000 Algiers, Algeria

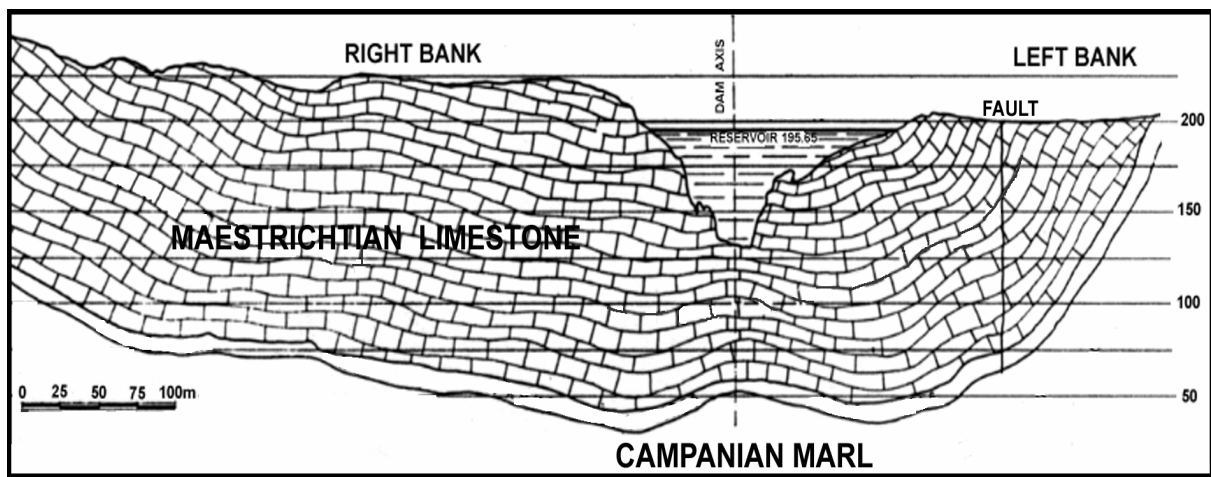
Figure 3. Geological cross-section of the dam site and geology of site surroundings

The massif where the dam is founded is composed of a relatively thick fissured karstic Maestrichtian limestone laying over a Campanian marl stratum (Fig. 3).

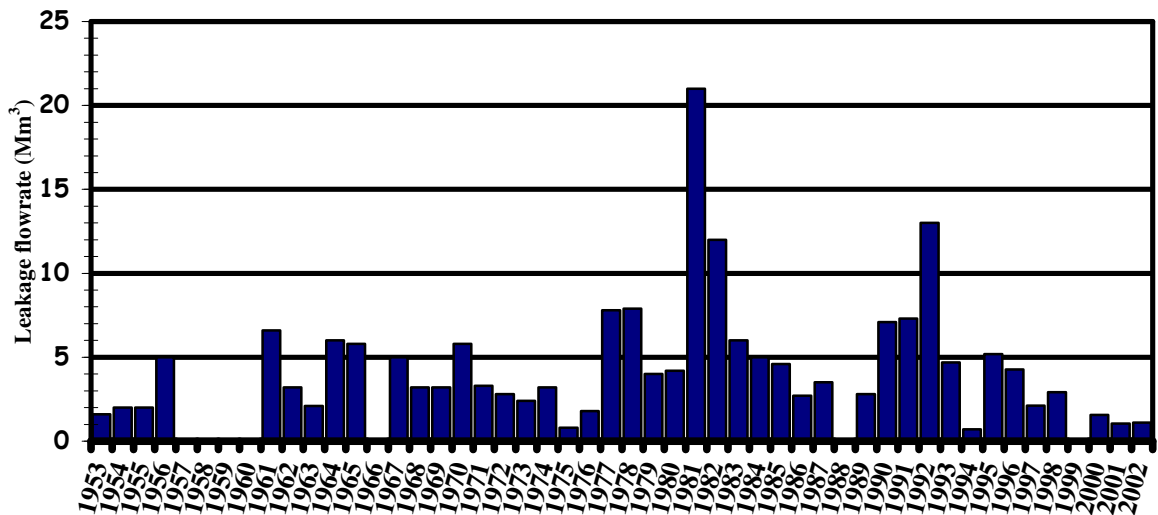
Figure 4. History of the leakage at Foum El-Gherza since first filling of the reservoir

The first filling and operation of the reservoir started in 1952 upon completion of the construction which was then resumed between 1954 and 1957 by the reinforcement of the hydraulic works and the injection of a grouting curtain. Just after dam filling, leaks started to appear at the immediate downstream of the dam (1.6 Mm^3 in 1952/53, $\sim 2.0 \text{ Mm}^3$ for the next two years,...). The maximum value was observed for season 1981/82 during which not less than 20.7 Mm^3 were recorded (Fig. 4). Due to lack of precipitation, the leakage rate started to fall down and during summer 1994 (June 24th) no more water was present in the reservoir.

Seepage takes place both at the left and the right banks. The leaks at the left bank are visible and their flow rate is rather low. They are collected within a small irrigation channel which follows the riverbed towards the irrigated areas. On the contrary, right bank leaks flow via a two-row network of drains and are directly collected within the irrigation gallery.

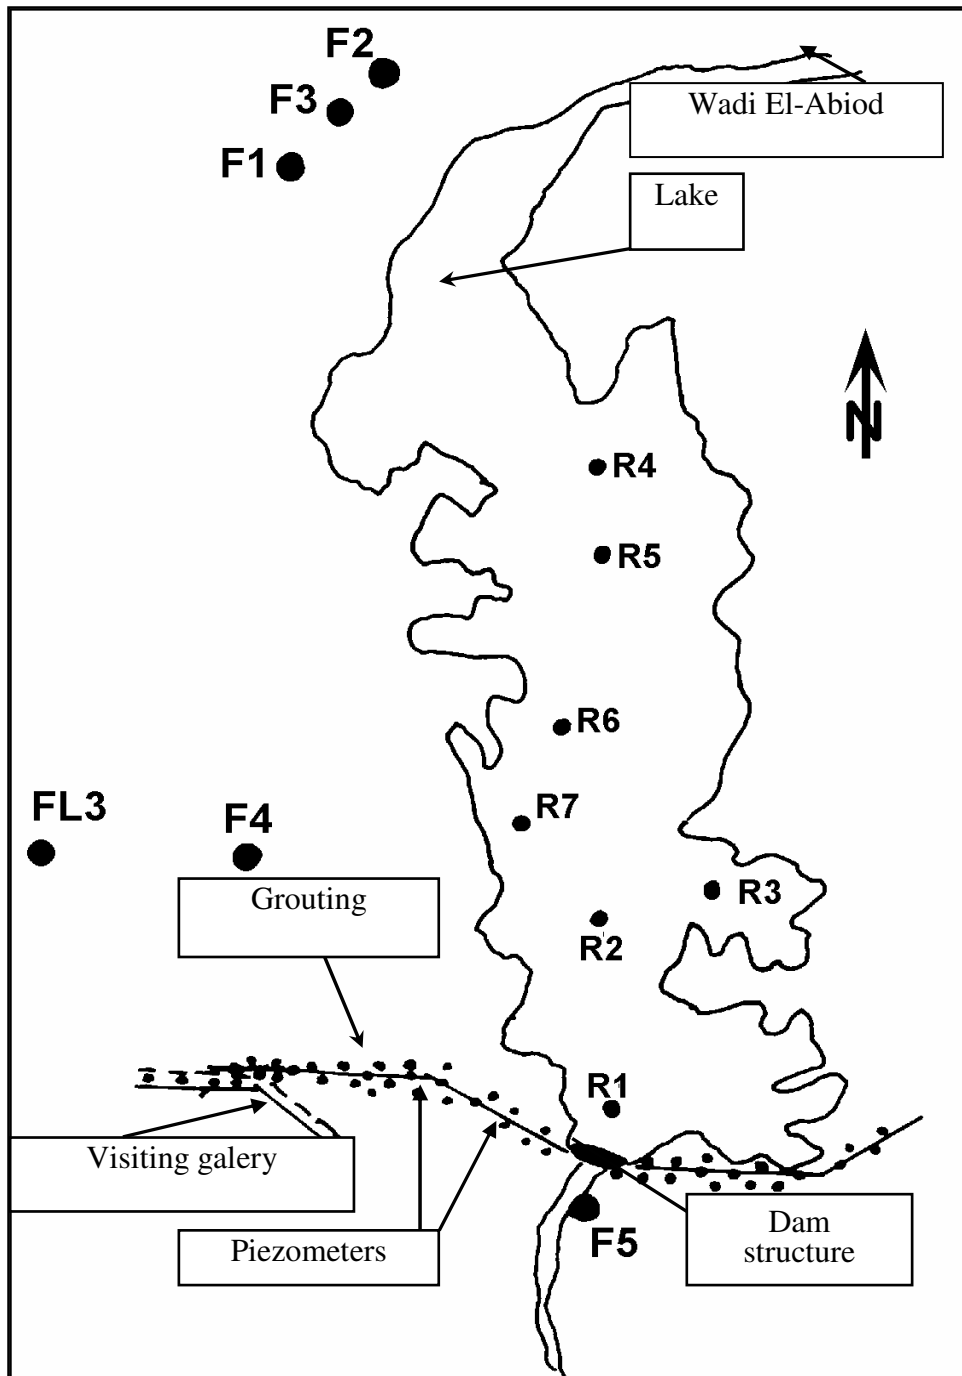
Figure 5. Schematic location of sampling sites during field campaigns

One evaluation mission and two field trips were carried out (Fig. 5). During the first field campaign, samplings for all water bodies that are present within the immediate vicinity of the dam were effected. In addition, conductivity and temperature profiles were recorded for the accessible piezometers on both banks and for some points in the lake itself.

The first in situ observations have shown the existence of lateral infiltrations through the massif. Land collapse and rockfall were also noticed. Excavations and large cracks were brought to sight by the decrease of water level in the lake (6.5 Mm^3 at that time). It was even possible to hear water flowing through the carbonate fractures on the left bank.

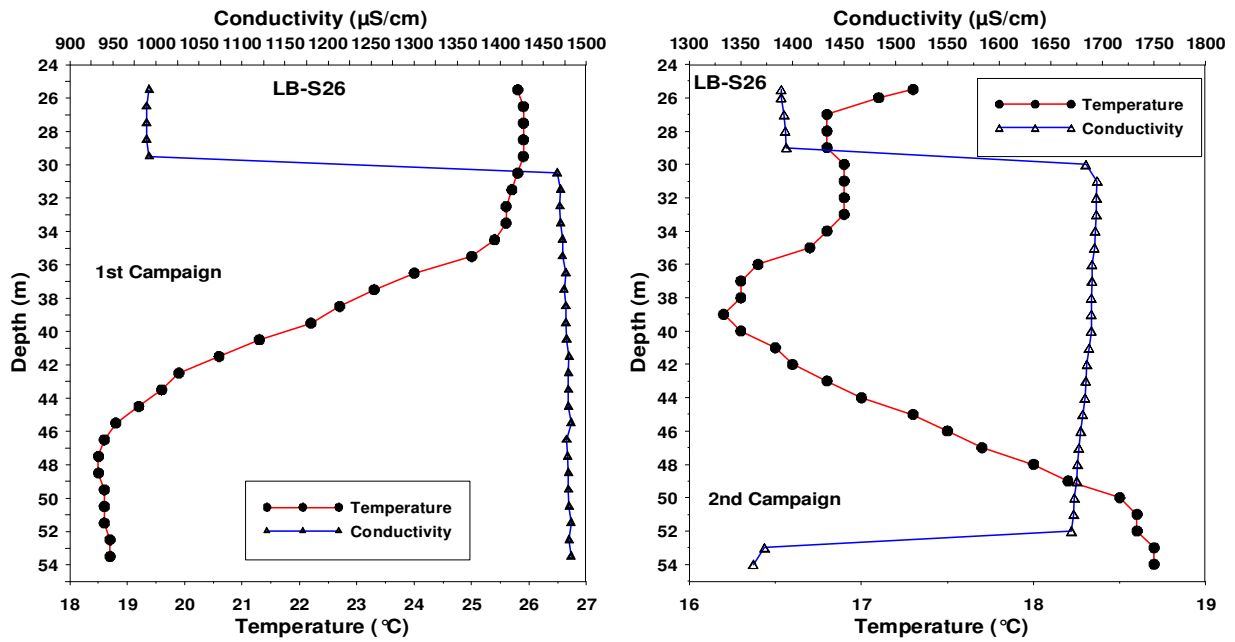
Figure 6a. Comparison of left bank S-26 piezometer EC & T profiles of the two campaigns

The results obtained from temperature and conductivity profiles that were drawn for the probe accessible piezometers have shown the presence of very complex vertical and horizontal flows as depicted in Figure 6a and 6b. This could be due to the geological characteristics of the site.

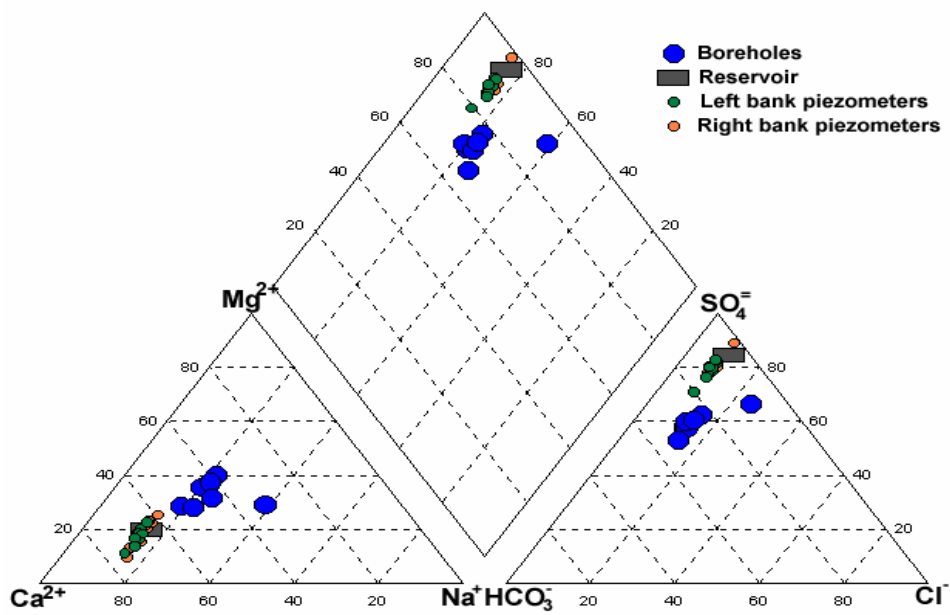
Figure 7. Chemical classification of samples according to Piper diagram

With regard to the chemical composition, a Piper diagram (Fig. 7) showed that there is no relationship between lake water and groundwater that is occurring in the immediate vicinity of the reservoir. This was further confirmed by the isotopic results through oxygen-18 and tritium contents as summarized in Table 1.

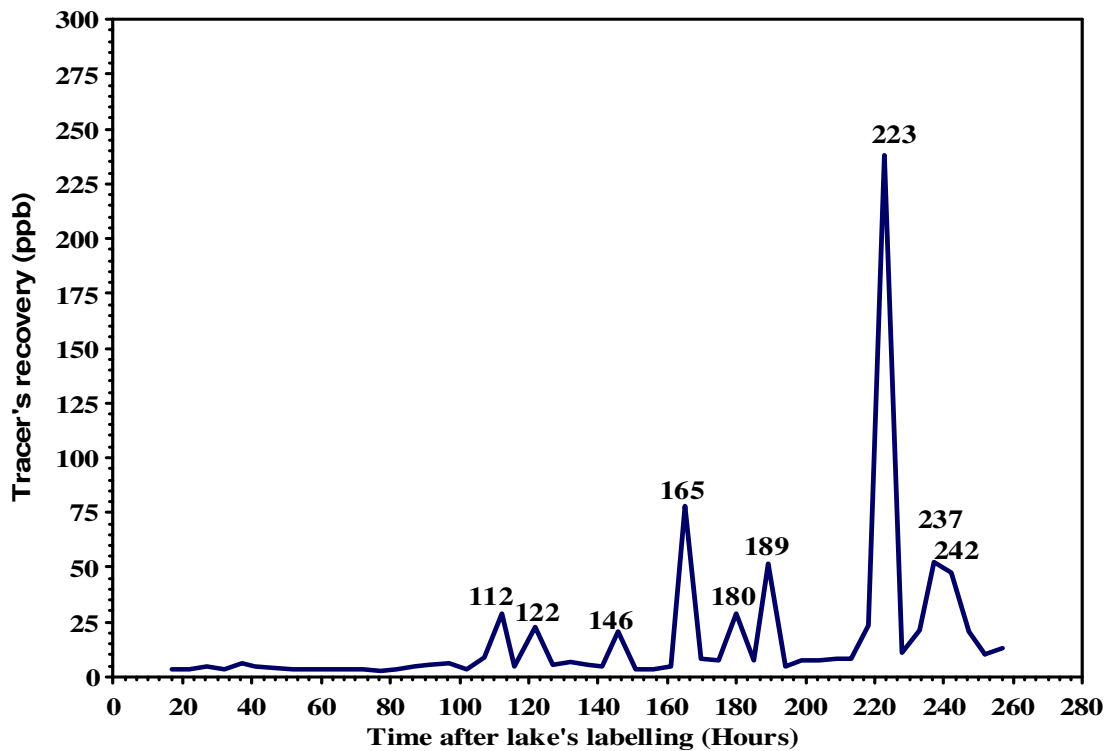
Figure 8. Tracer recovery as a function of time

An interconnection experiment using Rhodamine-WT fluorescent tracer was performed afterwards. It consisted of labelling the reservoir water at a distance of 2 m from the shores. The monitoring of tracer arrival at the downstream springs showed that Rhodamine was detected respectively after two days at the right bank and after one week at the left bank, since injection started (Fig. 8).

The investigation described in this paper led us to the conclusion that the implementation of such a pilot study and its associated preliminary findings seems to be satisfactory. However, according to the complexity of the geological site, more experiments need to be performed in order to better understand and better address the leakage phenomena.
